Flightfax

ARMY AVIATION
RISK-MANAGEMENT
INFORMATION

APRIL 1997 ♦ VOL 25 ♦ NO 7

Spatial Disorientation

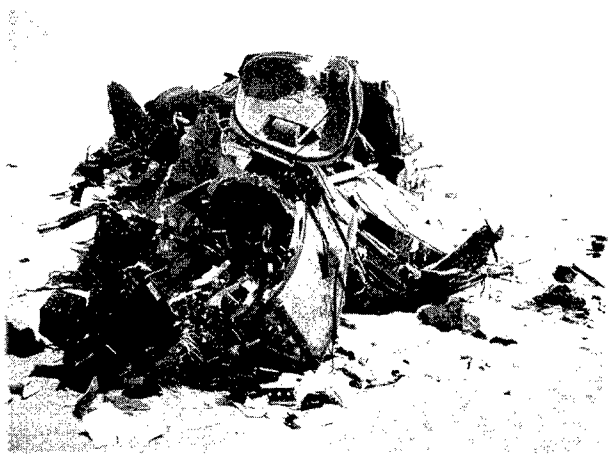
Type I SD: Aircrewmembers are *unaware* that they have an inaccurate perception of their position, attitude, or motion.

During an NVG orientation flight over desert terrain in a UH-60A, the pilot began a descent from 140 feet to his planned altitude of 100 feet. He initiated the descent without informing other crewmembers nor requesting their assistance in warning him if he passed through 100 feet agl. Due to inadequate visual cues, the pilot failed to arrest his descent and struck a sand dune in a near-level attitude at 69 KIAS at a 200-foot-per-minute rate of descent. All five people on board were injured, and the aircraft was destroyed.
